Fighting corrosion on rail networks in Asia

By Rick Simpson
Senior Corrosion Consultant, Zingametall

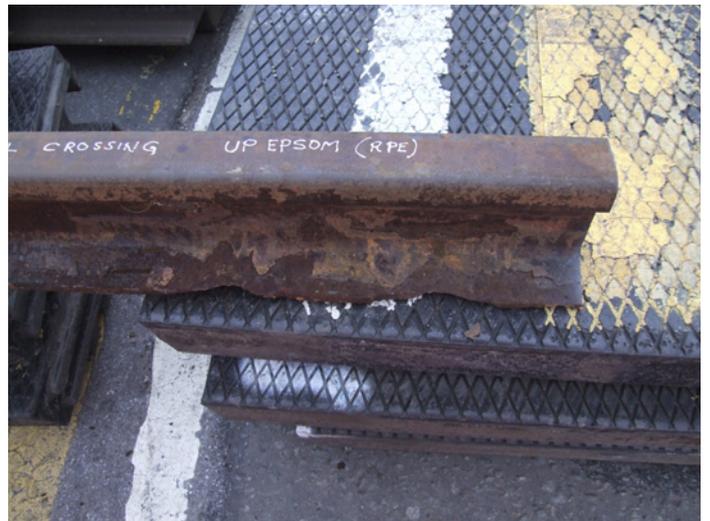
A corroded rail from the West Barnes crossing in East London clearly demonstrates that a rail with a predicted life of six years was written off within three months. It was this incident that triggered the whole rail-coating process and was followed by six years of intensive research and trials.

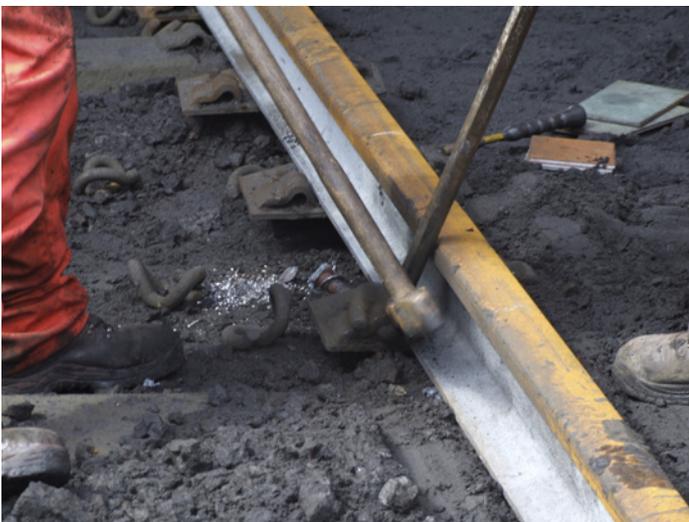
Coated rail being levered and hammered into position using a 7kg sledge hammer. A perfect response to questions asked about the impact-resistance of the Zinga coating!

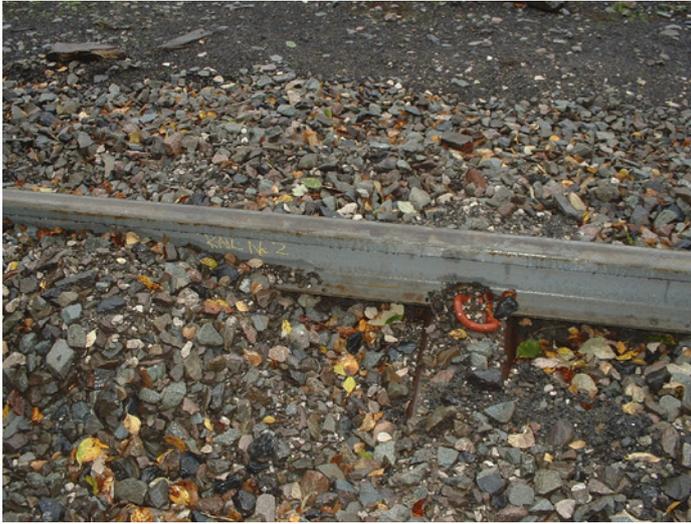
A zingarised rail in place.
